METALS HANDBOOK

VOL. 9
FRACTOGRAPHY AND ATLAS OF FRACTOGRAPHY

8th EDITION

Fractography and Atlas of Fractographs

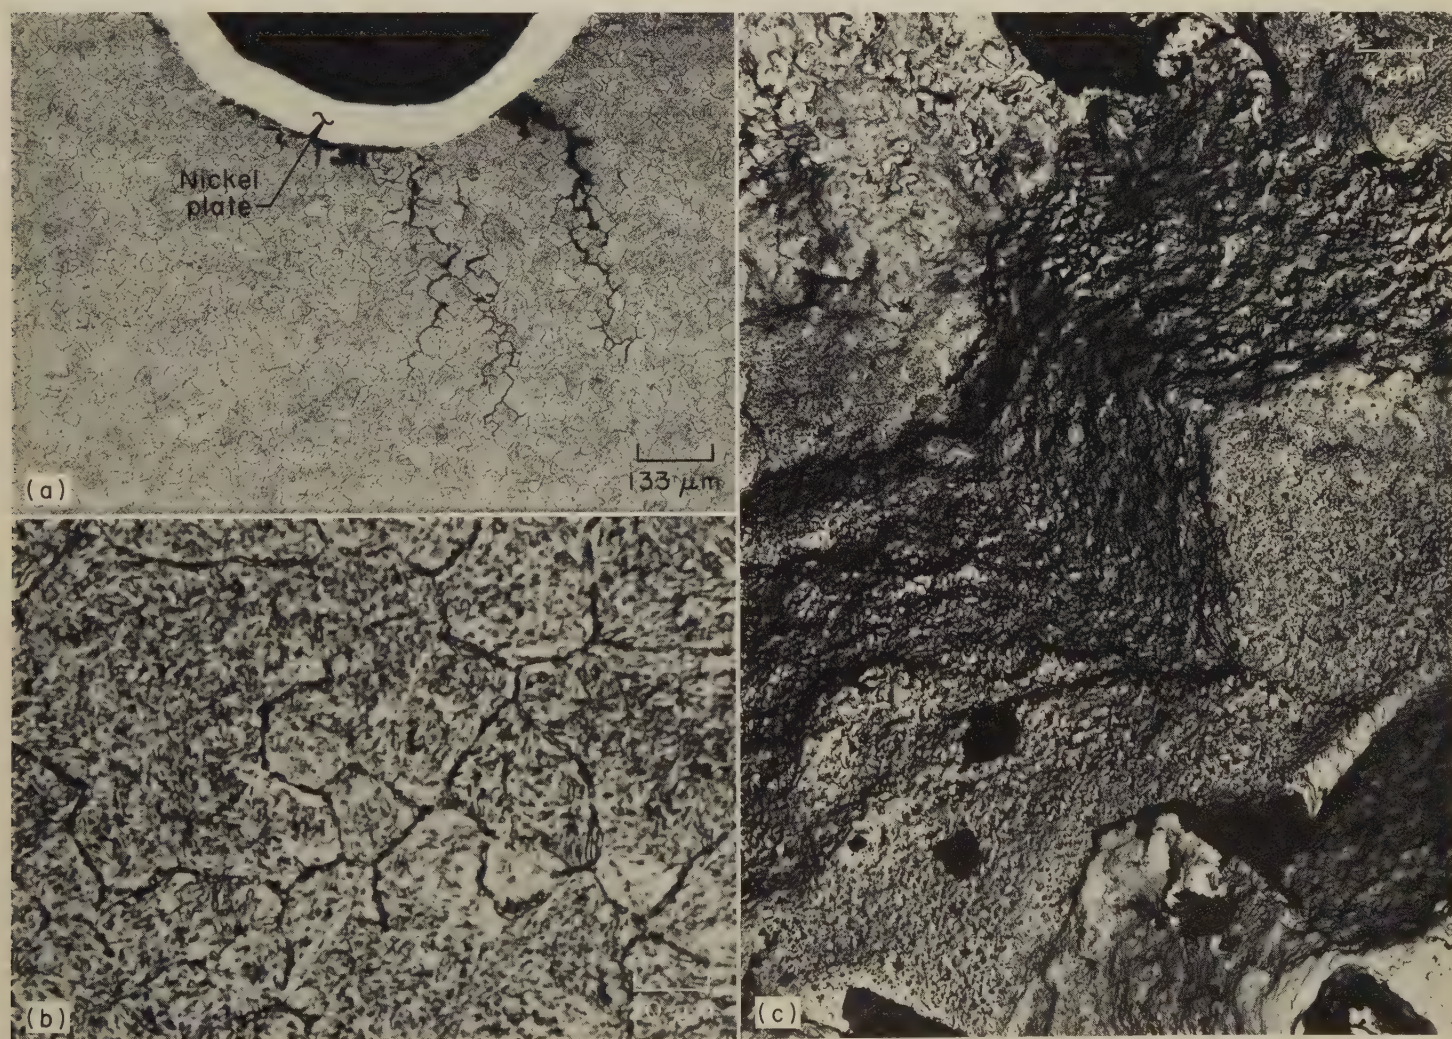
Micrographs (etchant: picral) 75× (a); 500× (b)
(a) and (b) Improper heat treatment resulted in excessive carbide precipitation at grain boundaries, and intergranular cracking occurred at roots of nickel-plated threads during service in a moist environment. Growth of stress-corro-

TEM fractograph (p-c replica) 2500×
sion cracks to a critical size resulted in brittle fracture of the stud.
(c) The fracture-initiation zone of the broken stud. Note the well-defined intergranular facets and evidence of corrosion on the fracture surface.

Fig. 14 Fracture resulting from stress-corrosion cracking in a 12% Cr stainless steel stud (see also Fig. 15)

Figures 14 and 15 show an intergranular fracture in a 12% Cr stainless steel stud. Excessive grain-boundary carbide precipitation resulted in intergranular stress-corrosion cracking during exposure to a moist environment in service, as shown in Fig. 14(a) and (b). Subcritical crack growth by this mechanism eventually resulted in brittle fracture of the stud after the development of a relatively small crack at the thread root. Figure 14(c) shows the fine-scale topography in the fracture-initiation zone, where crack growth was subcritical. Consideration of the conditions under which final fracture occurred and of subsequent mechanical-property tests indicated an abnormally low fracture toughness for the 12% Cr stainless steel used in making the stud. Fractographic examination of the area of final, fast fracture, and of toughness-test specimens, showed mixed mechanisms of fracture—transgranular zones charac-

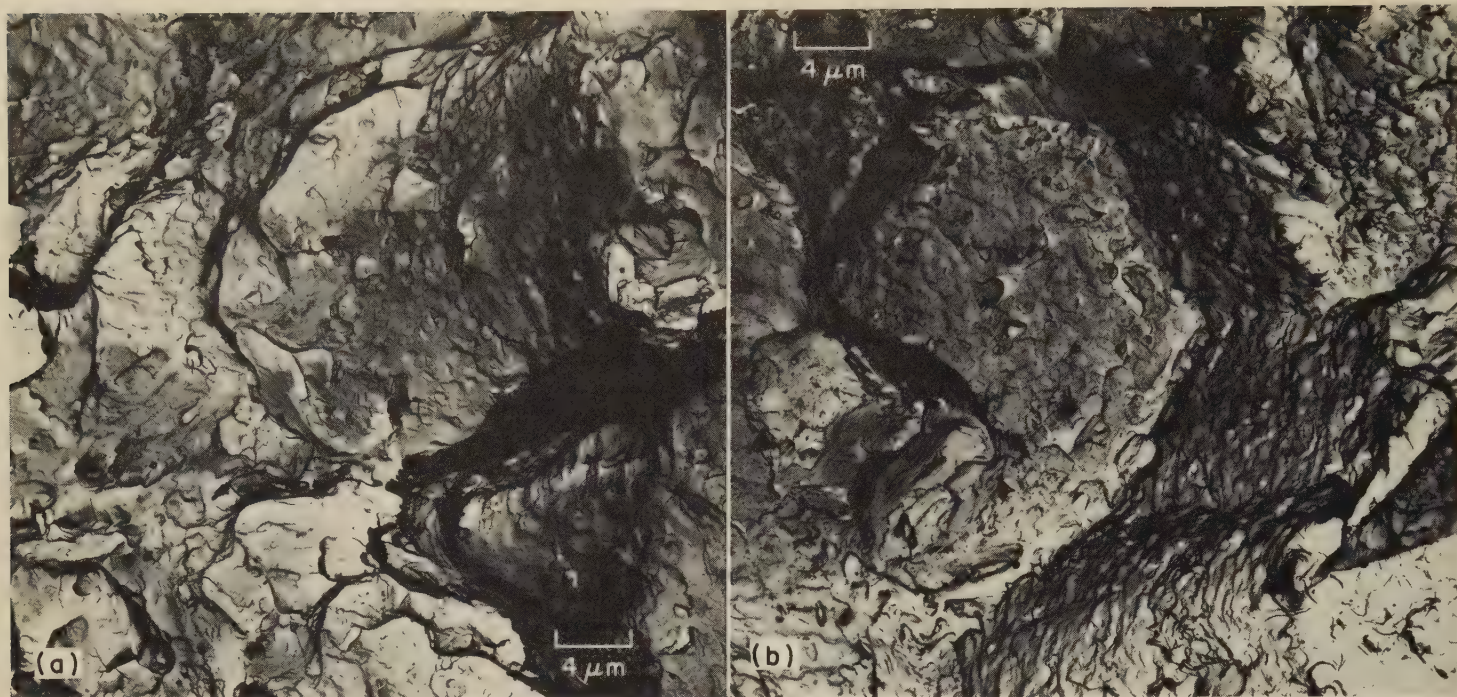
TEM fractographs (p-c replicas)
 (a) Area of final, fast fracture of the broken stud. Note mixed quasicleavage facets and dimples, and separated-grain facets. (b) Localized zone of separated-grain facets in final-fracture area of the broken stud. Small dimples can be seen on some facets. Dimples at upper right may be in a local region of transgranular fracture.

Fig. 15. Fracture resulting from stress-corrosion cracking in a 12% Cr stainless steel stud (see Fig. 14)

terized by dimples and quasicleavage facets, and a significant amount of intergranular separation (see Fig. 15). Classification of a fracture as intergranular on the basis of observations made in a limited area can thus be entirely erroneous.

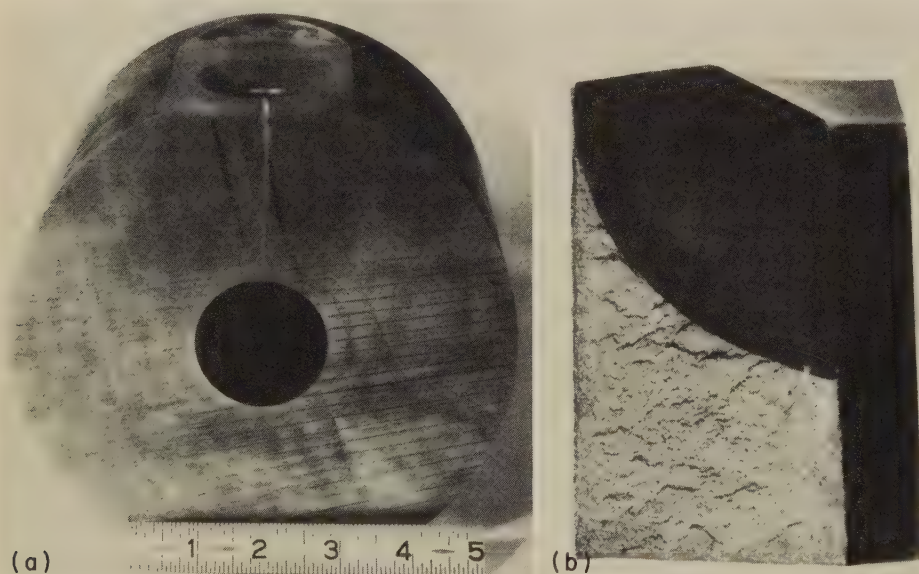
Photograph 3X Light fractograph 23X
 (a) Section cut through valve block showing magnetic-particle indications outlining a crack beginning in the shoulder of the valve port, at top, and extending to the primary bore, at center.
 (b) Corrosion-fatigue crack in a valve block similar to that shown in photograph (a). The crack, which terminates in an arc, is very smooth and has been darkened by the presence of corrosion products. The light-toned fracture surface below and to the left of the crack surface was produced when the valve block was broken to expose the fatigue crack.

Fig. 16. Valve blocks of 4340 steel that cracked in service from corrosion fatigue. See also Fig. 18 and 19. (Example 8)

Typical corrosion-fatigue cracks in valve blocks of 4340 steel heat treated to a hardness range of Rockwell C 32 to 35 are shown in Fig. 16. The transverse Charpy impact strength of the steel was 10 ft-lb at room temperature, which was considered normal.

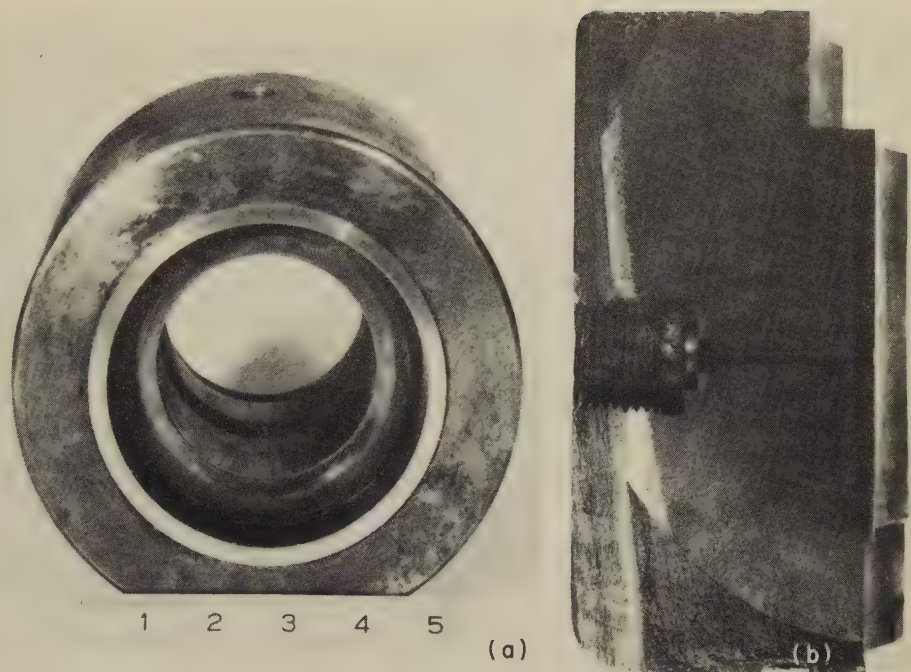
Photograph

(a) Over-all view of a packing retainer. (b) Packing retainer broken open for inspection, showing a corrosion-fatigue crack that penetrated nearly through

the full section. Cut at extreme left was made to permit opening of the fatigue zone, which is extremely smooth and shows effects of corrosion.

Fig. 17. Packing retainer of 4340 steel that cracked by corrosion fatigue (Example 8)

Figure 17(a) shows a packing retainer of the same material as the valve blocks (4340 steel); Fig. 17(b) shows a fatigue crack in a retainer that was purposely broken open for inspection. Note the smoothness of the crack surfaces (compare Fig. 16b and 17b), a result of the combination of fatigue and corrosion. The valve blocks and packing retainers were used in polyethylene-processing equipment.

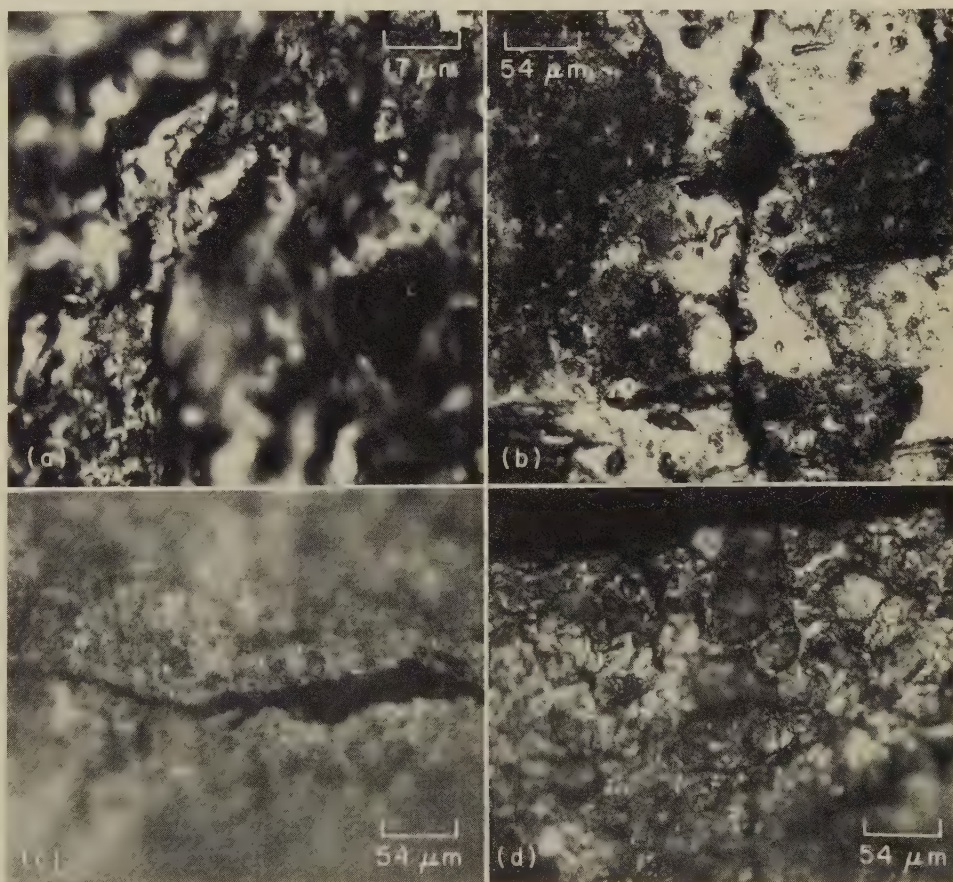
Light fractographs

(a) Fatigue striations at the crack tip that did not corrode. (b) Bore surface, showing corrosion pits and secondary cracks. (c) Elongated pit and crack at the rounded surface connecting the bore and the valve port. A pit-crack system like this initiated the

corrosion-fatigue crack that penetrated the valve block. (d) Surface of the crack at a point near the primary bore; separated-grain facets suggest that stress-corrosion cracking occurred early in the generation of the corrosion-fatigue crack.

Fig. 18. Areas of the corrosion-fatigue crack in the 4340 steel valve block in Fig. 16(b). See also Fig. 19. (Example 8)

The fracture surface of the valve block in Fig. 16(b) was examined at high magnification, establishing the presence of fatigue striations (Fig. 18a) at the crack tip and corrosion pits and associated secondary cracks (Fig. 18b and 18c) in the primary bore. One pit-crack system was the origin of the corrosion-fatigue crack that penetrated the valve block. Figure 18(d), which shows the fracture surface immediately below the primary bore surface, indicates that intergranular stress-corrosion cracking occurred early in the generation of the corrosion-fatigue crack. The fatigue striations that are faintly visible in Fig. 18(a), a light-microscope fractograph, are displayed more clearly in the TEM fractographs in Fig. 19.

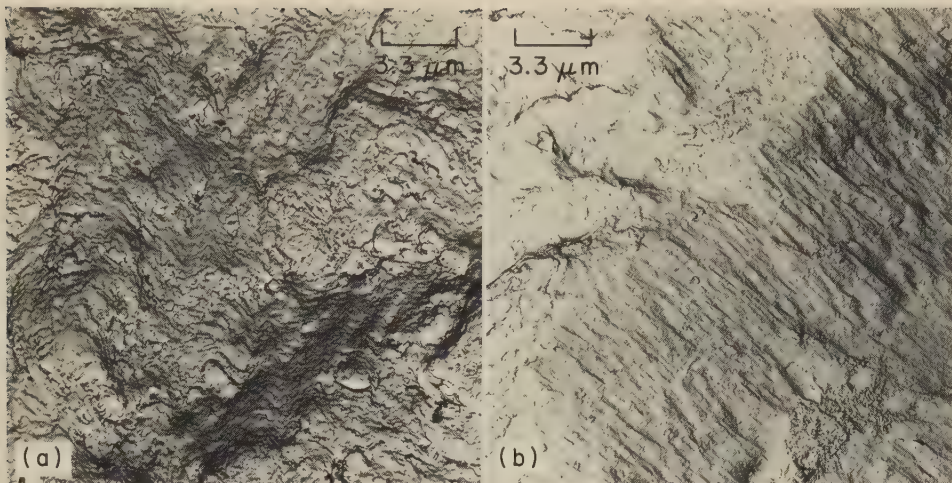
TEM fractographs (p-c replicas)

Both at 3000×

Fig. 19. Fracture surface at the tip of the corrosion-fatigue crack in the 4340 steel valve block in Fig. 16(b), as shown by TEM fractographs. The fatigue striations, which are only faintly visible in Fig. 18(a), a light fractograph, are clearly displayed here. There is also indication of a small amount of corrosion. (Example 8)

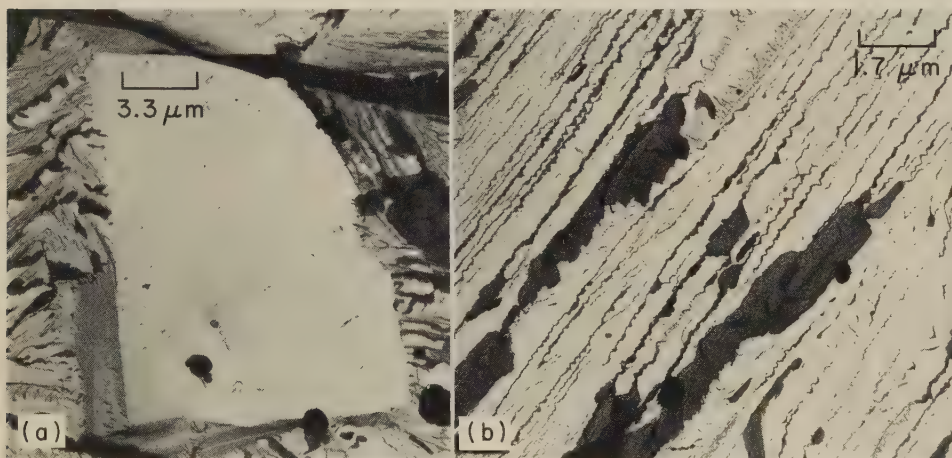
TEM fractograph (p-c replica)

3000×

(a) The large central facet is a separated-grain surface. Around it are irregular quasicleavage facets of transgranular fracture.

(b) Example of fine marks that might be mistaken for either stress-corrosion striations or fatigue

striations, but whose branched nature indicates that they are river patterns formed by cleavage steps. The dark patches are films of corrosion products extracted with the oxide replica. Compare with the fatigue striations shown in Fig. 21.

Fig. 20. Fracture surface of type 304 stainless steel tubing that cracked after exposure to a boiling solution of 42 wt % $MgCl_2$ (Example 9)

Stress-corrosion cracking resulted from exposure of type 304 stainless steel tubing to a boiling solution of 42 wt % $MgCl_2$. The fracture surface in Fig. 20(a) shows features that indicate a mixture of fracture mechanisms, none of them fatigue. The fracture surface displays a large intergranular facet surrounded by small, irregular transgranular quasicleavage facets. The intergranular separation was probably a result of a fortuitous grain orientation in the path of the advancing transgranular stress-corrosion crack. Figure 20(b) displays closely spaced marks that might be mistaken for fatigue striations, or for crack arrests that occurred during stress-corrosion cracking. Close scrutiny, however, reveals the presence of many fine forks of a river pattern, created by cleavage steps. The crack propagated from upper right to lower left. See Fig. 21 for true fatigue striations.

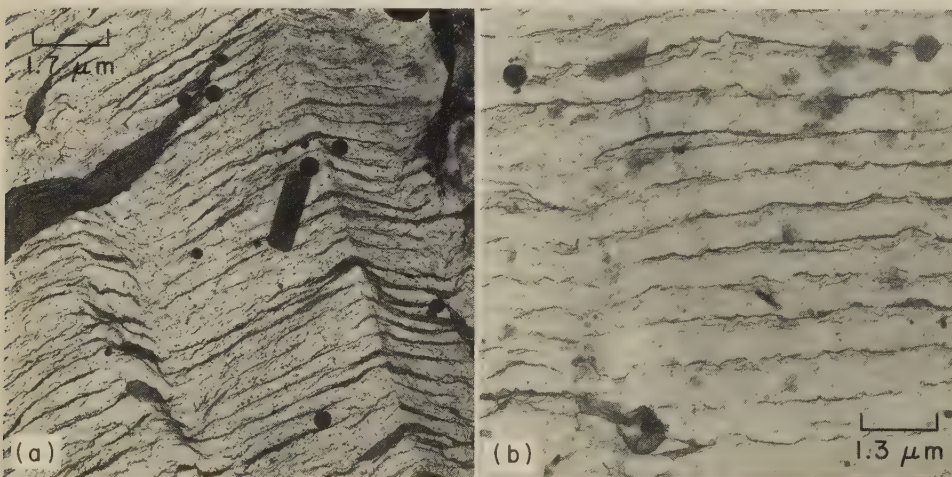
TEM fractograph (oxide replica)

5750×

(a) Striations have different orientations on either side of a tilt boundary (at right). Cyclic loading was in air; corrosion was not involved. (b) Striations show no evidence of corrosion (see Fig. 22).

The fracture in Fig. 21 resulted from cyclic fatigue-stress loading of type 304 stainless steel in air (under "dry" conditions). No evidence of corrosion is apparent on the striations. A slightly different appearance is presented in Fig. 22, which shows a fracture surface of a specimen of type 304 stainless steel that was broken in concentrated $MgCl_2$ at 60 C (140 F) under cyclic loading. The fracture has been superficially roughened by corrosion and the fatigue striations are still clearly visible. It is evident, therefore, that fatigue was the major mechanism of fracture and that corrosion had only a modest effect.

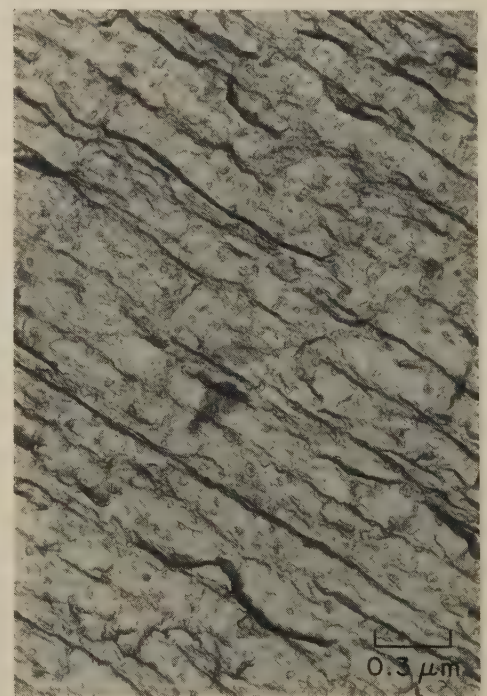
TEM fractograph (p-c replica)

30,000×

The fracture has been superficially roughened by corrosion, and the fatigue striations are clearly visible. There is also a suggestion of secondary fissures in some of the striations. Compare with Fig. 21.

Fig. 22. Corrosion-fatigue fracture produced by application of cyclic stress to type 304 stainless steel exposed to a concentrated $MgCl_2$ solution at 60 C (140 F) (Example 9)

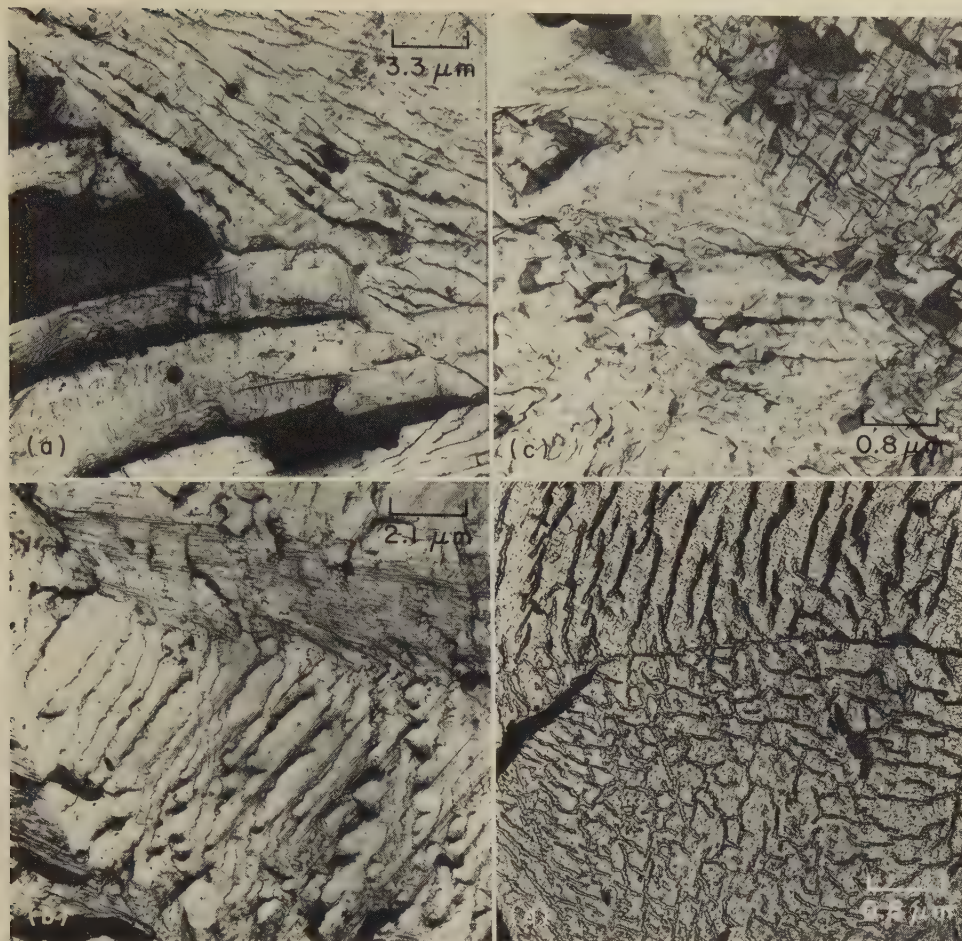
TEM fractographs (oxide replicas)

(a) At lower left is a region of gross secondary cracks, which give a woody appearance. Segments between the cracks show fine cross marks that are not fatigue striations. At upper right is a diagonal system of branched cleavage steps, also with fine marks that are not fatigue striations.

(d) A "worm tracks" area, an unusual example of a cobweb network of stress-corrosion cracks on the fracture surface. A grain boundary appears to cross the field a third of the way down from the top.

Fig. 23. Fracture surface of a stainless steel pressure-gage Bourdon tube that cracked because of attack by diphenyl oxide-diphenyl mixture (Dowtherm) that had absorbed water from a leak (Example 9)

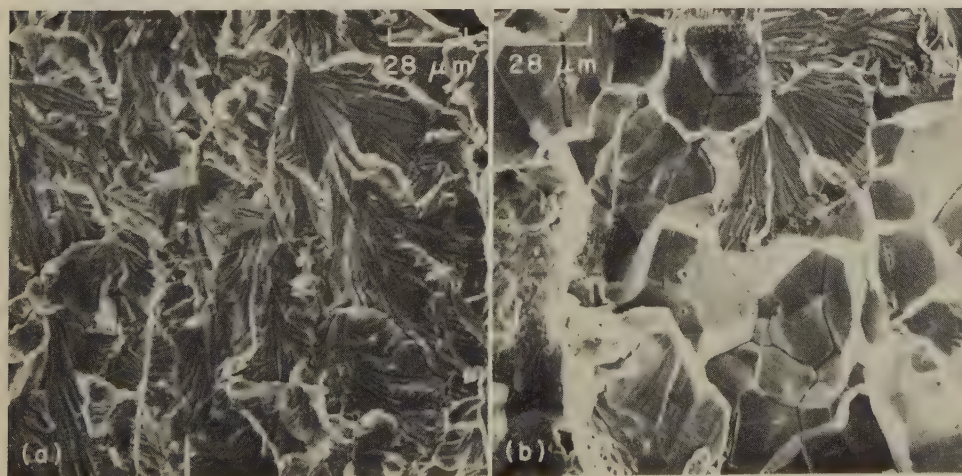
SEM fractographs

The fracture in general exhibited the fan-shaped or feather-shaped transgranular cleavage features shown in (a). In a hasty scrutiny, the presence of local areas of "rock candy" intergranular fracture,

A fracture in a specimen of type 316 stainless steel is shown in two views in Fig. 24. These may be compared with Fig. 20(a) and (b) because the transgranular stress-corrosion crack that caused the fracture in Fig. 24 was also induced by exposure to a boiling solution of 42 wt % $MgCl_2$. The view in Fig. 24(a) is of cleavage facets with feather marks, which were largely characteristic of the entire fracture. However, Fig. 24(b) displays an area of "rock candy" intergranular fracture that could have been overlooked in a superficial examination. There is a possibility that corrosion-generated hydrogen may have caused local hydrogen embrittlement and the very clean intergranular separation. There is no evidence of corrosion on the grain facets.

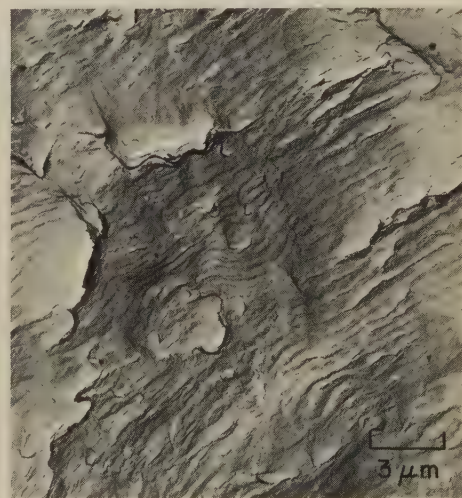
TEM fractograph (p-c replica) 3300×

Fatigue patches separated by tear ridges are apparent. The appearance of the surface at left and at upper right suggests that rubbing occurred after the crack front passed.

Fig. 25. Fatigue striations in the surface of a fracture in type 316 stainless steel (Example 9)

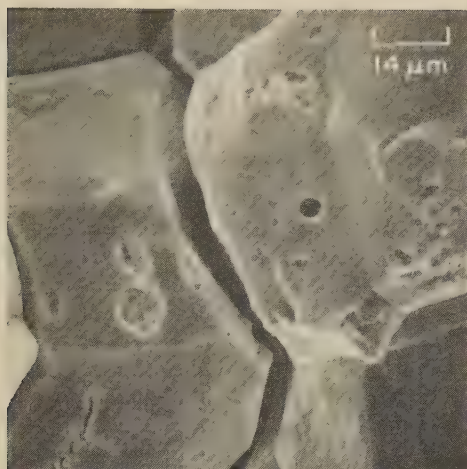
SEM fractograph 700×
The part was a component in a pressurized reactor system operating at 300 to 500 C (572 to 932 F) and was exposed to gaseous HCl containing 3.6% H₂O and 13.0% AlCl₃. Note the deep secondary cracks. The separated-grain facets display evidence of corrosive attack.

Fig. 26. Intergranular fracture in Hastelloy C-276 (Example 10)

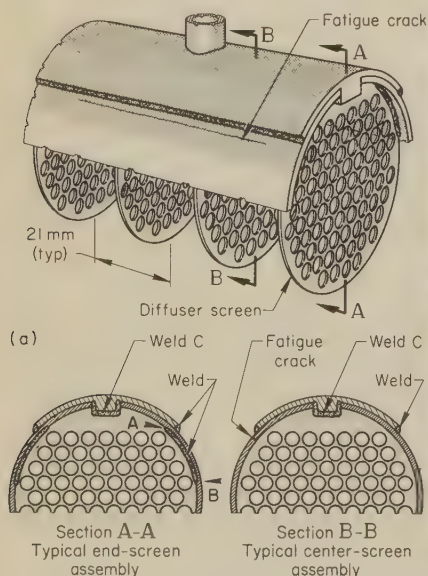
(a) Radiator assembly, showing change in wall thickness, location of crack, and position of diffuser screens. Views A-A and B-B show the locations of the welds that secured the screens to the shell wall. (b) TEM fractograph (plastic-carbon replica), at 7700×, showing fatigue striations on the crack surface.

Fig. 27. Fatigue crack in the shell of a section of an aircraft hydraulic radiator assembly made of aluminum alloy 2024-T6 (Example 11)

A longitudinal crack was found in the shell of a section of an aluminum alloy 2024-T6 radiator assembly (Fig. 27a). The radiator contained diffuser screens spaced at intervals of 21 mm along the length of the shell. The two end screens were firmly attached to the shell wall over the length AB (see view A-A in Fig. 27a), thereby acting as wall stiffeners. The two center screens were attached only by weld C, as shown in view B-B in Fig. 27(a), leaving the wall unsupported.

Examination of the fracture surface revealed no obvious macroscopic features to indicate the mechanism of fracture. Electron-microscope fractographic examination revealed well-formed fatigue striations (Fig. 27b) whose orientations intimated that the

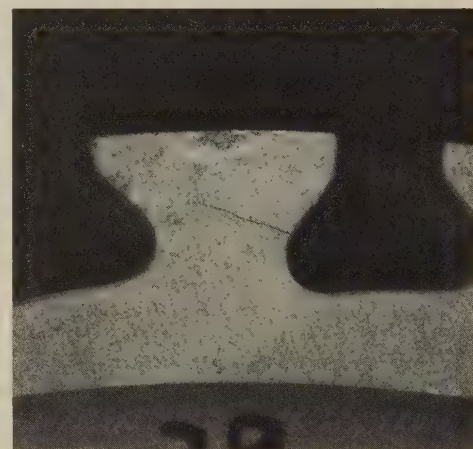
Photograph 3×
Fig. 28. Service-induced crack on rear side of tenon of aircraft-engine compressor disk forged of aluminum alloy 2014-T6. See also Fig. 29 to 31. (Example 12)

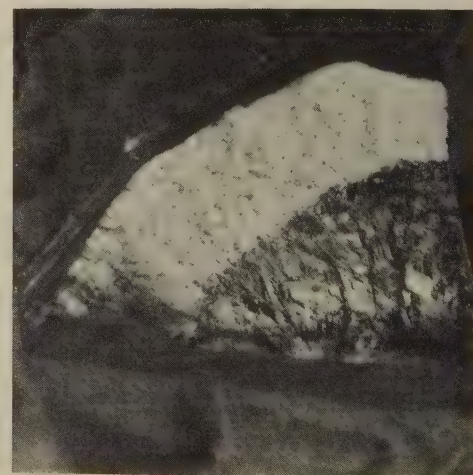
Light fractograph 7×
Fig. 29. Fracture surface of cracked compressor-disk tenon shown in Fig. 28. Light-colored area is fresh fracture formed in breaking the crack open. There is no evidence of fatigue. See also Fig. 30 and 31. (Example 12)

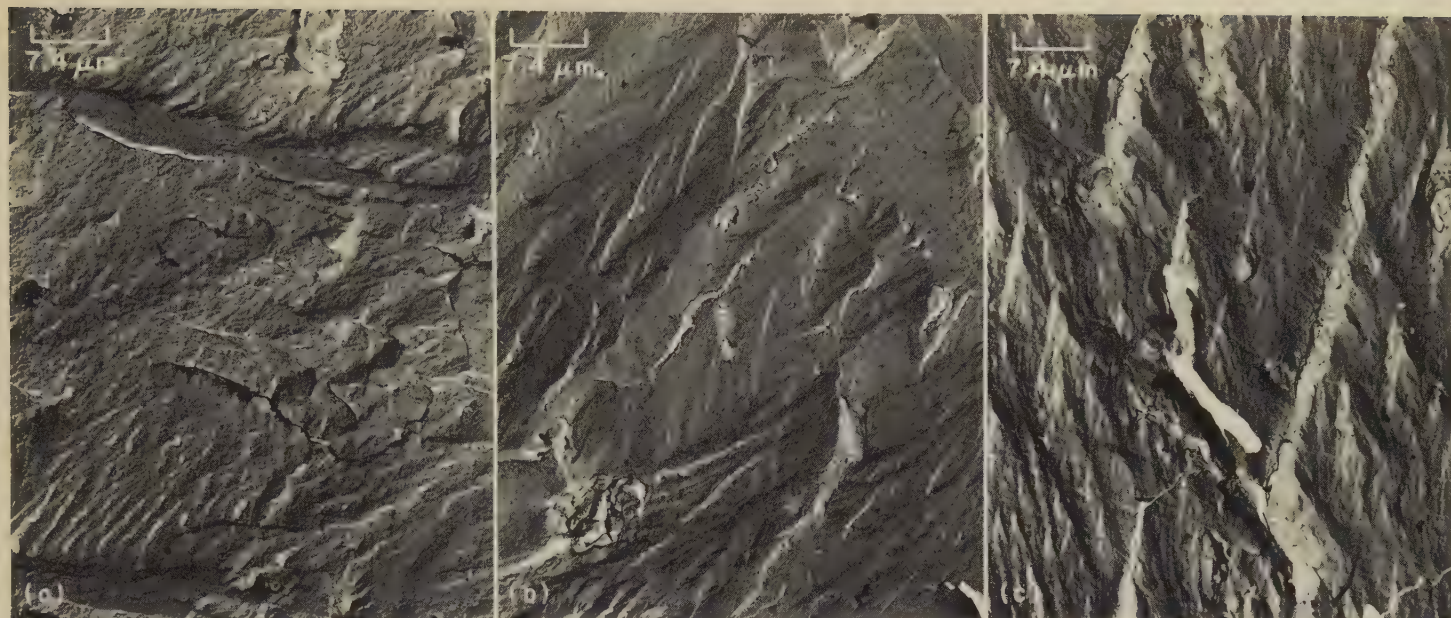
TEM fractographs (p-c replicas)

All at 1350X

The cleavage-type features (coarse river patterns) shown in (a) and (b) were typical of the central portion of the crack surface and the region near the origin. No striations indicative of fatigue were evident in those zones. Isolated areas of widely spaced striations superimposed on cleavage-type features as in (c) were observed near the crack tip.

Fig. 30. Surface of the crack in the compressor-disk tenon of Fig. 28 and 29. See also Fig. 31. (Example 12)

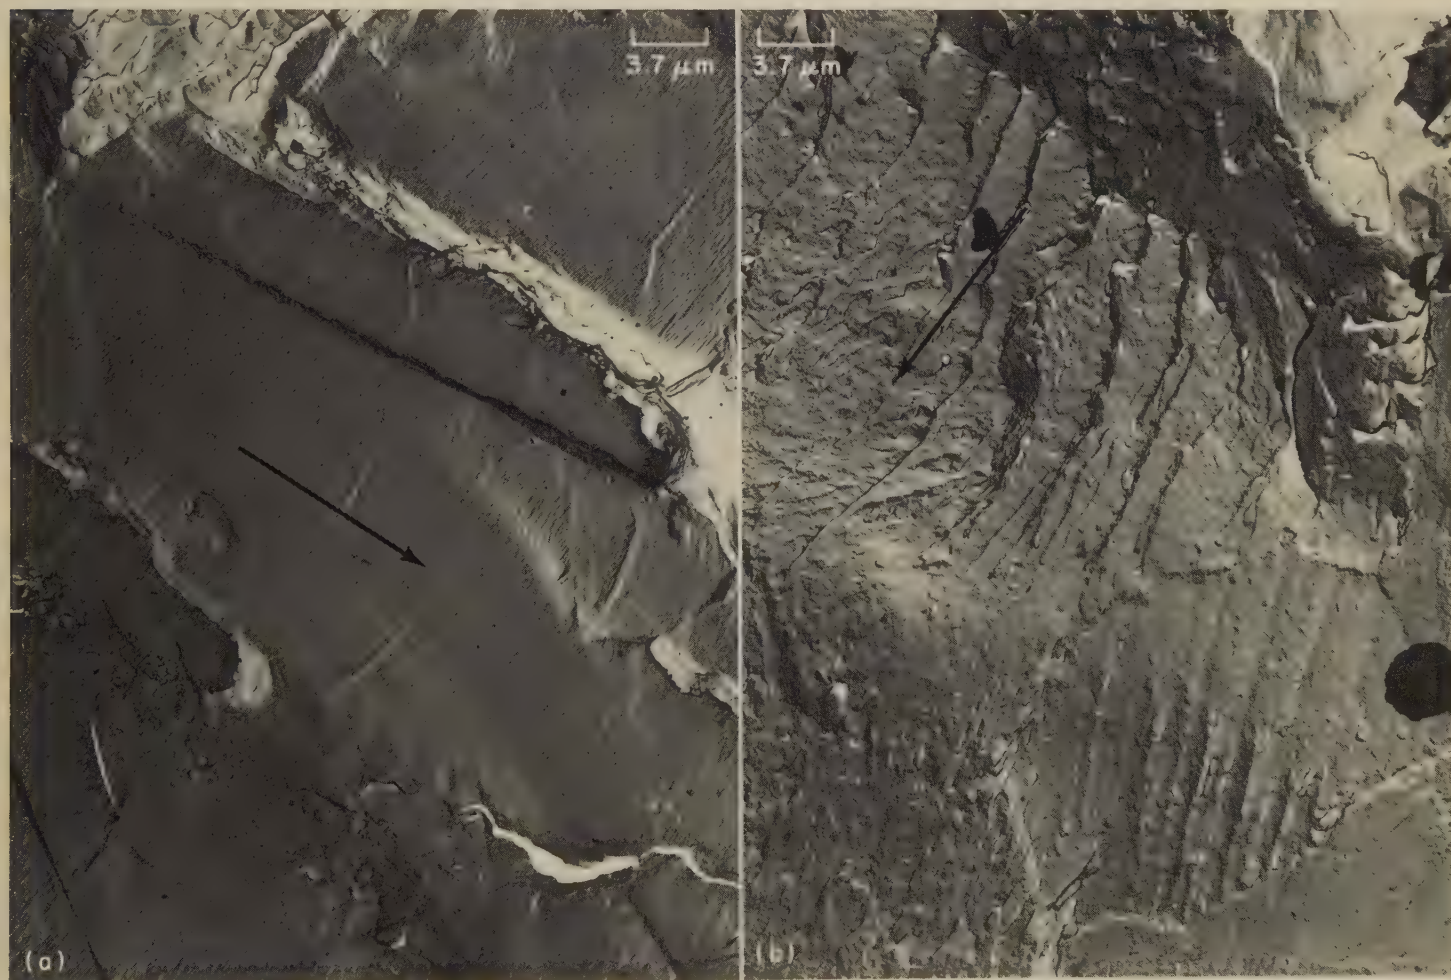
TEM fractographs (p-c replicas)

Both at 2730X

(b) Coarse cleavage-type steps, resembling those in Fig. 30, in a fracture area where crack-growth rate was 1.2 micro-in. per cycle. This is typical of areas where crack-growth rate was 1.2 micro-in. per cycle or less (see Ref 1 and 2).

Fig. 31. Two areas, with different crack-growth rates, of a fracture surface of a laboratory fatigue-test specimen of aluminum alloy 2014-T6, the same material as that of the compressor-disk forging in Fig. 28 to 30. Arrows indicate direction of crack propagation. (Example 12)

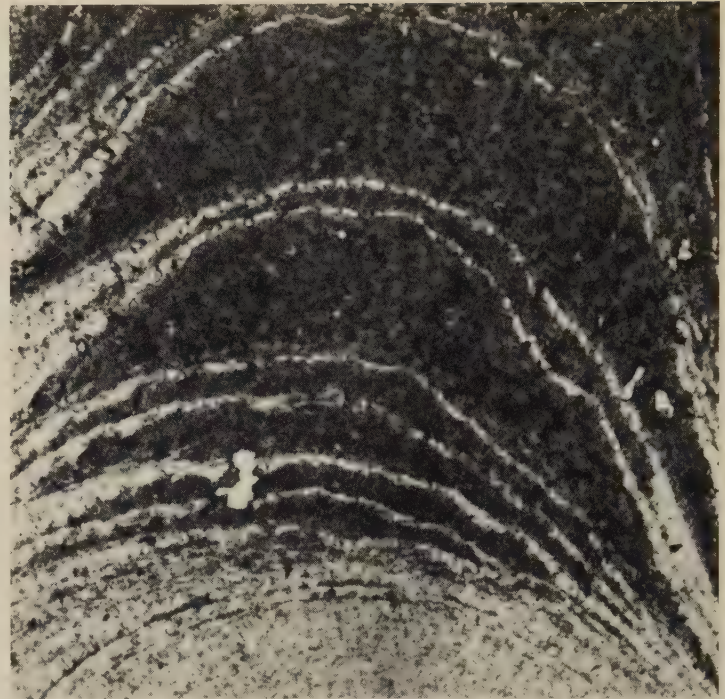
Transmitted-light fractograph (through plastic replica)

7×

Fig. 33. Macroscopic crack-growth bands on the surface of a service fracture in a forged aluminum alloy 7075-T6 aircraft component. Higher magnification showed fatigue striations in narrow, bright bands, and ductile dimples in wider, dull bands.

Another kind of macroscopic feature that has been observed, usually in the later stages of fatigue-crack growth in service fractures, consists of a pattern of alternate bright and dull bands. Figure 33 shows macroscopic crack-growth bands in a fracture of an aluminum alloy 7075-T6 aircraft component. Microscopic fatigue striations were observed in the narrow bright bands; the wider dull bands contained ductile dimples. These features indicate intermittent fatigue interspersed between episodes of limited fast fracture.

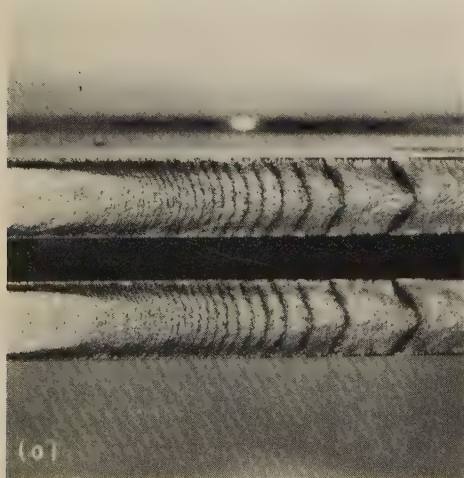
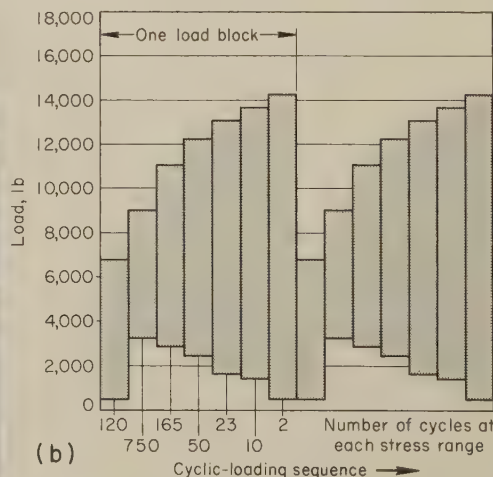
Fig. 34 Effect of cyclic-loading spectrum on macroscopic crack-growth-band spacing in aluminum alloy 2024-T3. See also Fig. 35 and 36. (Example 13)

(a) Photograph, at 2X, showing typical fatigue crack-growth bands on the mating surfaces of a fracture in an aluminum alloy 2024-T3 main-spar web of an aircraft wing that was subjected to a repetitive

cyclic-loading spectrum. The aluminum alloy was fabricated as rolled sheet.

(b) Cyclic-loading spectrum that produced the fatigue-crack-growth bands shown in (a).

faces of laboratory fatigue specimens that have been subjected to repetitive, sequential, programmed loading. Fractographic examination has indicated that there is a one-to-one correspondence between a load block (see Fig. 34b) of the cyclic-loading spectrum and the formation of a band on the fracture surface. Although it is not always clear precisely why the bands are visible, they have been shown, in the early stages of crack growth, to represent alternate changes in the plane and type of crack propagation. The next three examples describe instances where band counting and study were used to determine crack-growth rate, and where this information was employed in preventing further fractures.

test (Ref 5) are shown in Fig. 34(a). The repetitive-load spectrum, based on flight-load measurements, is illustrated graphically in Fig. 34(b).

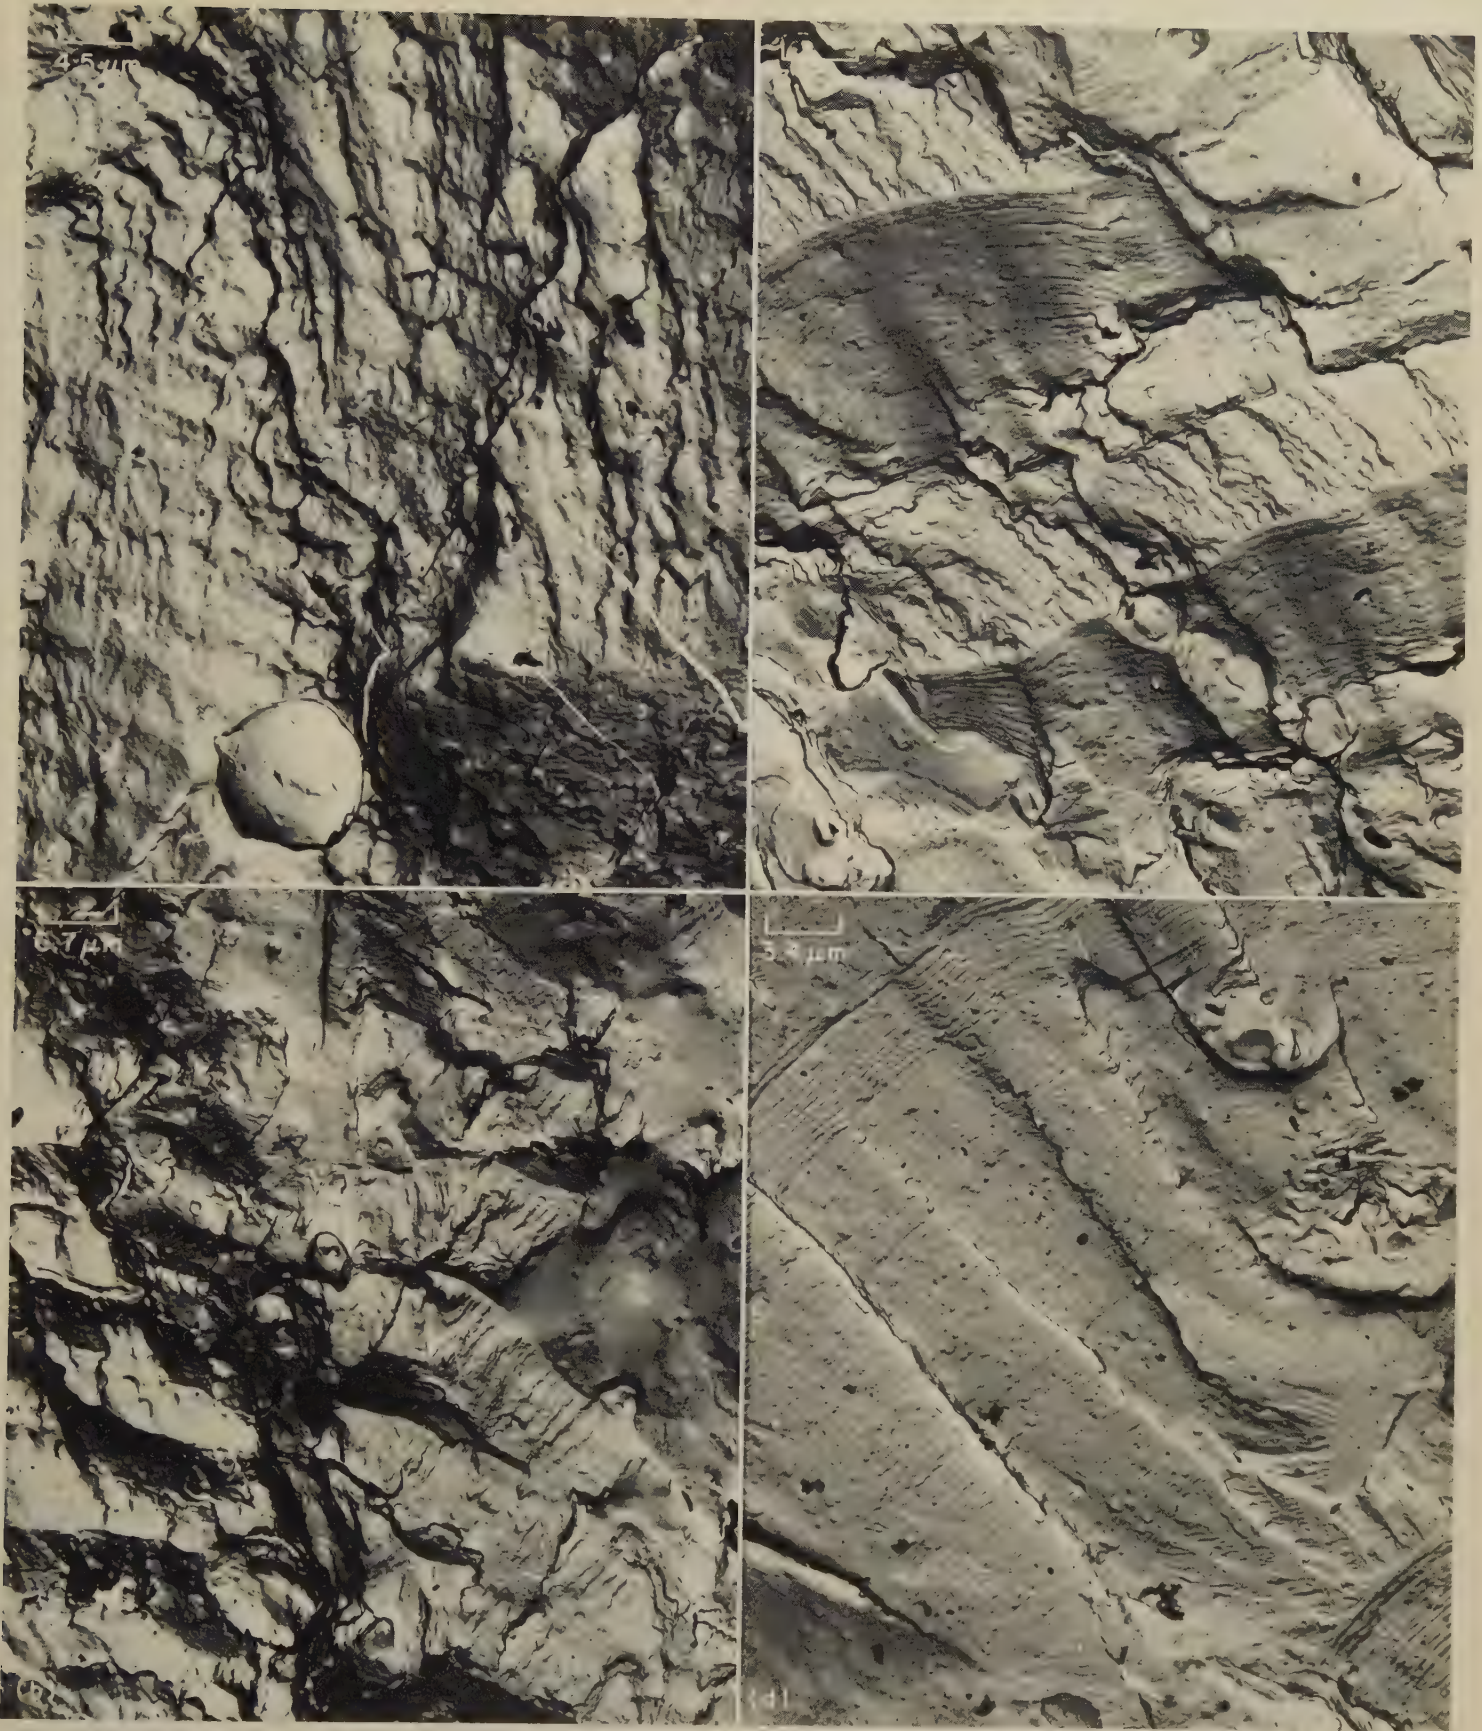
Fig. 35. Fatigue-crack-growth bands at various distances from the crack origin in the aluminum alloy 2024-T3 spar web of Fig. 34, which was fatigue tested to fracture. See also Fig. 36. (Example 13)

TEM fractographs (p-c replicas)

(a) Crack-growth bands at a distance of 0.1 mm from crack origin. Striation-band spacing, 3.0 microns. Striations from individual load cycles not visible.
 (b) Crack-growth bands at 0.3 mm from crack origin. Striation-band spacing, 11.5 microns. Alternate changes in plane of crack propagation and small areas of finely spaced striations from individual load cycles are visible.

(c) Crack-growth bands at a distance of 0.6 mm from the crack origin. Striation-band spacing is 16.0 microns. Bands of striations are visible.
 (d) Crack-growth bands at a distance of 1.5 mm from the crack origin. Five load levels of the spectrum are clearly resolvable by striation spacings and cycle counts. Striation-band spacing is 32.0 microns.

At a crack penetration of 0.1 mm from the point of crack nucleation, the bands had a spacing of 3.0 microns and did not exhibit resolvable striations corresponding to the individual load cycles of the spectrum (Fig. 35a). At a crack penetration of 0.3 mm, the bands had a spacing of about 11.5 microns and exhibited repetitive changes in the plane of crack propagation as well as small groups of finely spaced striations representing individual load cycles (Fig. 35b). At a crack penetration of 0.6 mm, band spacing had increased to 16.0 microns and striations from individual load cycles were clearly resolvable (Fig. 35c) between the striation-free bands that had apparently formed during application of the lower loads of the spectrum. At a crack penetration of about 1.5 mm from the crack origin, band spacing was about 32.0 microns. Figure 35(d) shows well-defined striations that formed in response to the higher cyclic-load levels of the spectrum. The striations could be readily related to the stress conditions that generated them from their relative spacings and from striation counting. In the later stages of fatigue-crack growth, dimpled areas were observed between the macroscopically visible crack-growth bands.

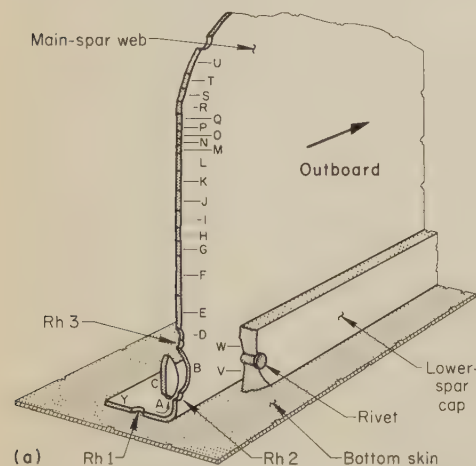
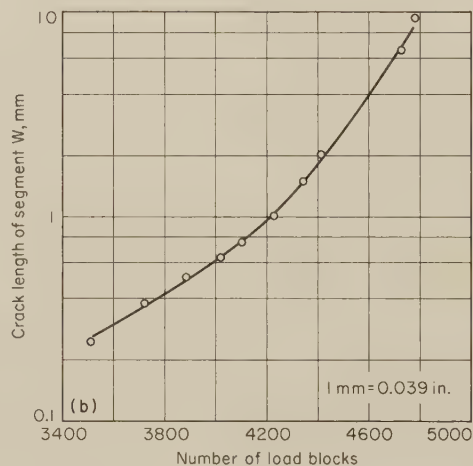
Fig. 36. Fracture of main spar (a) of aircraft wing (see Fig. 34) in programmed-loading fatigue test, showing the various crack segments. (b) Crack depth versus number of applied load blocks for segment W of the fracture surface. (Example 13)

The wing shape and the location of the internal fatigue cracks were such that the observation of crack growth was impossible during the course of the fatigue test. Because the main objective was to gain information concerning the moment of crack initiation and the rate of crack growth in the spar structure, a fractographic traverse of the fracture surface was undertaken to determine these in retrospect. A sketch of the fractured spar, indicating the various crack segments, is shown in Fig. 36(a), and a plot of crack length versus the number of applied load blocks for one of the segments, segment W, is given in Fig. 36(b).

Study of the crack-propagation rates revealed that the total time for crack growth from initiation at rivet hole 1 (Rh 1 in Fig. 36a) to segment U was approximately equivalent to 26,000 flying hours. The total endurance of the wing structure was about 48,000 flying hours. It was concluded that the exis-

tence of such a crack should be detectable shortly after 20,000 to 25,000 flying hours, long before it could reach any unstable rate of growth. The fracture of segments V and W conformed to the same time relationships. Figure 36(b) illustrates how determination of crack-growth rate based on fatigue-band counts, which indicate the number of applied load blocks, can be used to predict the number of flying hours that a spar can be used before a crack may become unstable, and to offer assurance that properly timed inspections will detect such cracks soon enough to avoid fractures in service.

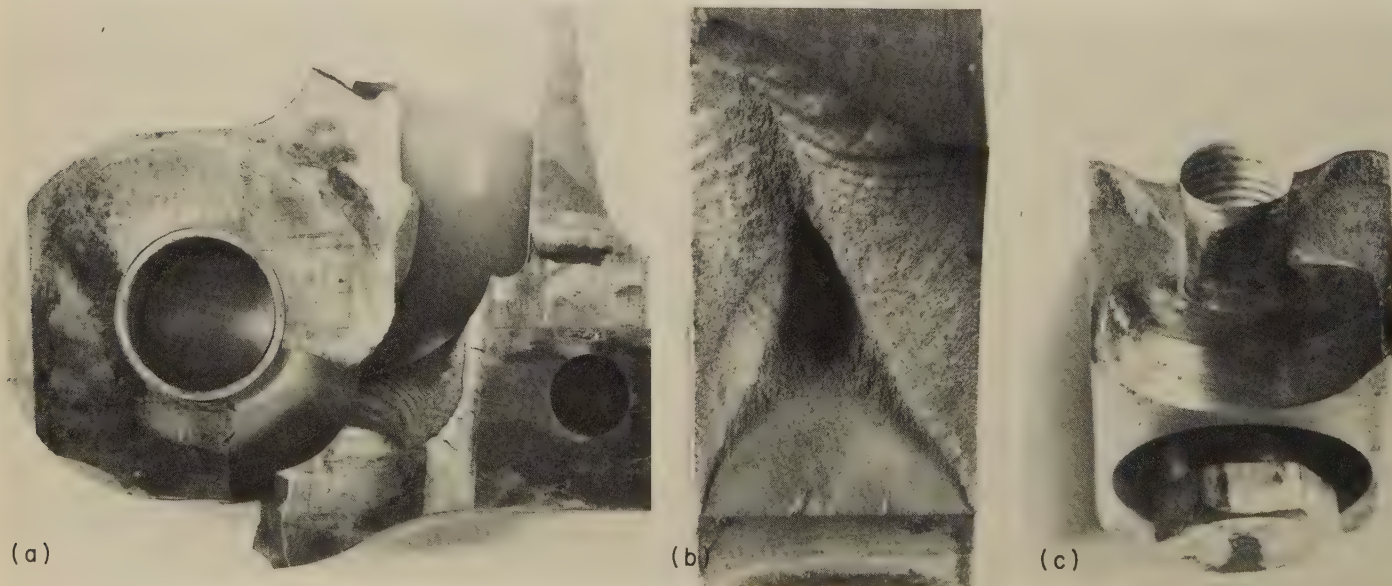
Light fractographs

Fig. 37. Fracture surfaces of a 4340 steel finger from a main-wing transport joint that fractured in a full-scale programmed aircraft fatigue test (see also Fig. 38). (a) A fractured finger. (b) Surface of the major critical crack. (c) Surface of a less-critical crack in the vertical member. (Example 14)

Measurements of crack-growth rate were made on two fingers (one of which is shown in Fig. 37a) from a main-wing transport joint that had fractured during a full-scale programmed aircraft fatigue test. The fingers were made of 4340 steel heat treated to a tensile strength of 1350 MPa (196 ksi) and a hardness of Rockwell C 41 (microstructure was tempered martensite). The crack-growth histories, as derived from band counts on

two of the fracture surfaces, shown in Fig. 37(b) and (c), are given graphically in Fig. 38(a) and (b), respectively.

- 1 The critical cracks in both fingers, running from the bottom of the U between the two vertical members of the fingers to the large bolthole, appeared to have been initiated at approximately the same time. It was estimated that the crack in each finger was about 0.3 mm in depth when 150 load blocks had been applied, and that the crack-growth rates were similar during the first 10 mm of penetration depth.
- 2 The less-serious crack in each of the vertical members of the fingers (Fig. 37c) grew at a much greater initial rate—a
